CAPITAL NEEDS ASSESSMENT

***WOODPARK APTS.
1 Woodpark Lane
Hoosick Falls, NY 12090***

RIGHT-TRAK DESIGN, INC.

Date: 19 April 2010

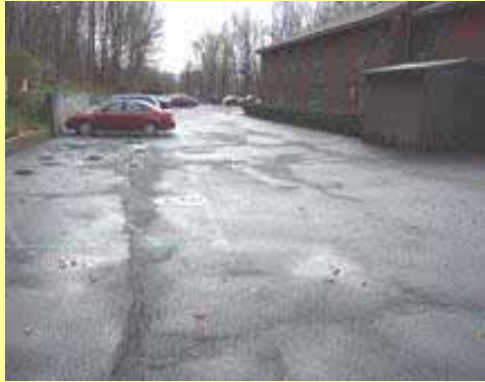
The parking lot has a capacity of 36 parking spaces (including 4 accessible spaces). The parking surface exhibits surface cracking and areas of settlement. The road entrance was resurfaced in 2003 (\$5,000) and the parking lot was sealed in 2002. The parking spaces including the accessibility markings will need to be resriped. There is a 5-foot wide concrete walkway along the west side of the property. Several slabs have cracked, displaced, and heaved.

View looking across the parking lot

- Budget costs to resurface the lot in Year 1.
- Costs are shown every five years starting in year 5 to crackfill and sealcoat the paved parking areas.
- Budget in year 2 for sectional walkway replacement.

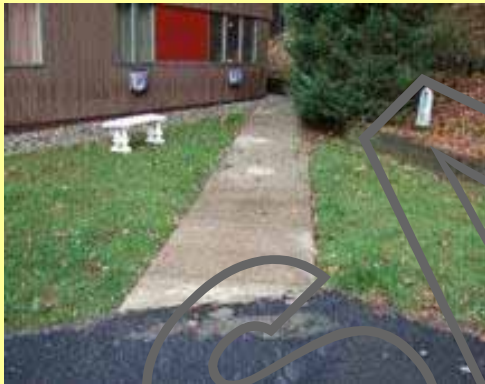
View of one of the concrete walkways

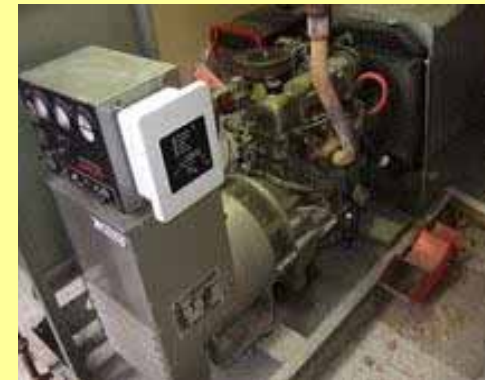
View of the 3-phase generator located in the shed

- Budget to replace the smoke detectors in years 5 and 15.
- Budget to replace the emergency wall lights.
- Budget in year 7 to perform additional generator overhaul and repairs.

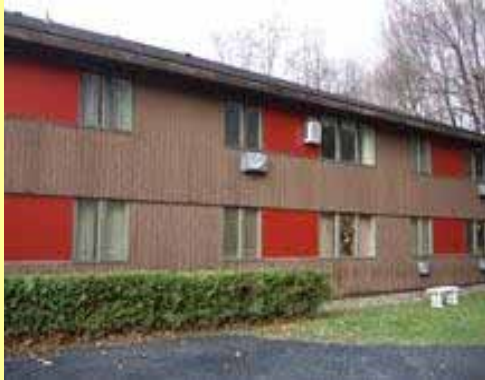
Typical view of the exterior siding

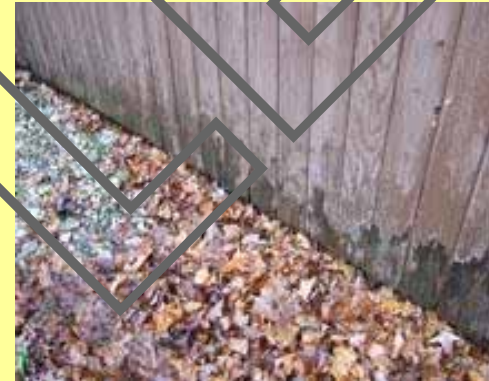
There is a storage shed located on the entrance to the building. The shed has T1-11 siding and an asphalt shingle roof covering. There is a second storage shed with a metal roof covering that houses the generator. The lower edges of the T1-11 are water damaged. Re-siding is included with exterior walls below.

Typical view of the water damaged edges of the siding

- Budget in year 2 to re-side the first three feet of the building with a non-porous material, other siding repairs and paint.
- Budget in years 10 and 20 for a second paint cycle.
- Budget in year 8 to re-seal/paint the wood deck.

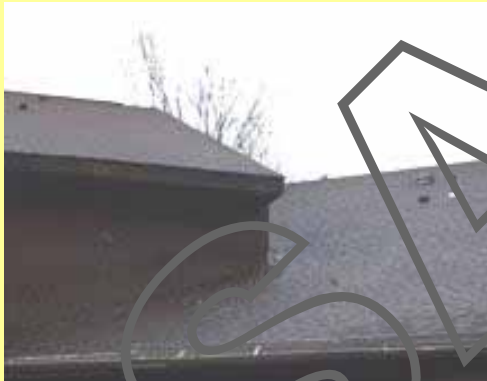
The roof structure has a 5 in 12 slope and includes 2x12 rafters at 16 inches o.c. The roof is covered with asphalt shingles. The original shingles are 240# on 15# felt. The roof above the office and north end of the building was replaced in 2009. The shingles at the south side are curled and deteriorated. This area is planned to be sealed in 2009. Ridge vents have been installed. There is 12 inches of fiberglass batt insulation in the attics. Rainwater drainage is provided by limited sections of aluminum gutters at the south side of the building. Maintain as needed through routine operations.

View of the two different ages of roof covering

- Budget to replace the remaining roof covering in year 1.

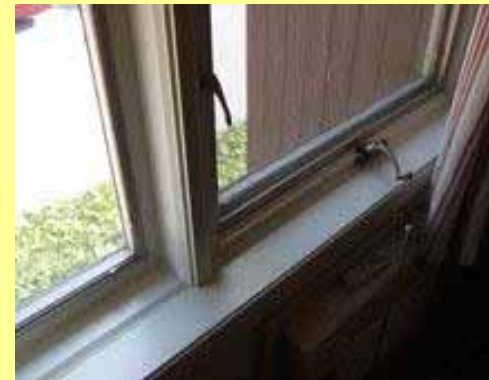
Window frames are wood with single glazed lites typically arranged with a center picture window flanked on each side by an operable awning window. The window lites have an insert storm window. Other configurations include the crank out awning type. The windows that were tested operated properly, however several lites did not close properly in their frames. The main entrance door has a 34-inch clear opening with a 49-inch clear space between the inner and outer vestibule doors when opened. The main door locks were replaced in 2007. There are several exterior steel doors with a glazed half lite located around the building that provides additional means of egress from the building.

View of the window frames

- Budget in year 2 to replace the windows.
- Budget in year 7 to replace the entrance doors.
- Budget to replace the solid exterior doors in year 7.

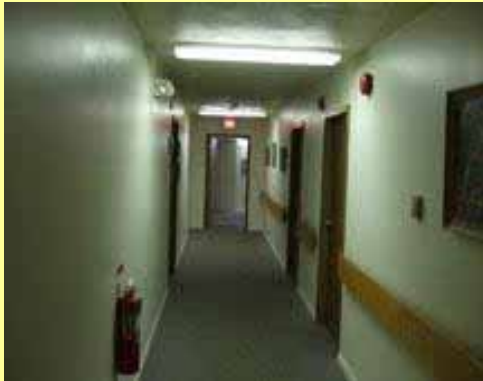
Common area walls have a painted finish and a mix of painted mopboard. There is a rounded wood handrail on one side of the hallway. Areas of water staining were observed on the upper floors. The ceilings have a texture painted finish. Some water staining was observed on the finishes of the upper floor. The hallways, community room floor and kitchen have carpet flooring. The carpet was replaced around 2000. Isolated areas of staining were observed. The hallways have a wall-mounted railing. Maintain as needed through routine maintenance. Hallway fire doors are by Warnock Hersey and are rated at 1.5-hours. The doors have closers, wired vision panels, and are held back on magnetic releases. Several of the fire doors have warped and do not close properly. The doors to the laundry have a 33-inch clear opening with lever hardware. The door to the main office has a 34-inch clear opening. There is a recessed wall-mounted mail facility located in the hallway. The accessible boxes are at 51" and 46" high. The mailbox has a 57-inch high outgoing letter slot. Interior common area lighting is provided by 2x4-foot T12 fluorescent 40W tubes. All fixtures were replaced in 2000. Electric fan coil panels are located in the stair ways. Maintain as needed through routine maintenance.

View of the hallways.

- Budget in years 6 and 16 for hallway painting.
- Budget in year 1 to repaint the ceilings.
- Budget to replace the damaged doors (H&S).
- Budget in years 2 and 12 to replace the carpet.

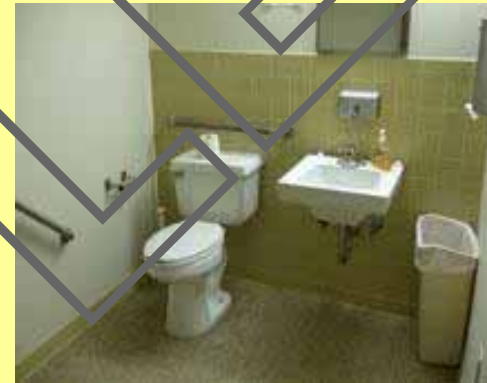
The restroom doors have a 34-inch clear door opening and the restrooms have a 60-inch turning radius. Fixtures include a UPC toilet with a seat height of 19-inches. Lavatories are wall-mounted with a single handled faucet, aerator, and pipewrap. The fixtures are in good condition. Maintain as needed through operations. The toilet paper holder is fixed at 25-inches high and is not in-line with the toilet. The grab bars are 1.5-inches dia., 1.5-inches from the wall, and 24-inches long. The grab bars are not in compliant positions. The mirror is located at 53-inches, the soap holder is at 42-inches, and the paper-towel holder is located at 46-inches.

View of the common area restroom

- Budget to replace the community room kitchen cabinets in year 1.
- Budget in year 1 to replace the countertop in conjunction with cabinet replacement.
- Budget in year 1 to relocate the medicine cabinets and toilet paper holder, and install grab bars in compliant positions.

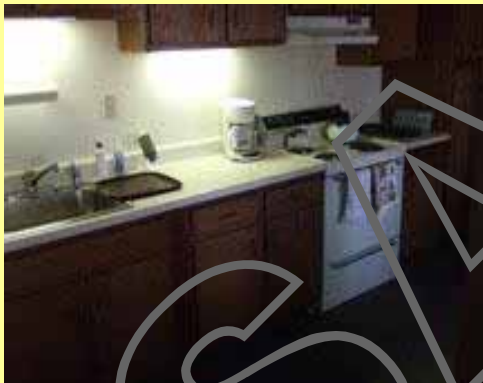
The community room kitchen cabinets are located adjacent to the community room. The cabinets have solid wood face frames. The cabinets do not meet ADA in that there is no knee space. The community room kitchen non-compliant countertop is a rounded edged laminate particleboard fixed at 36-inches high. There is a compliant single bowl stainless steel sink with a single handled faucet, aerator, and spray attachment. The kitchen appliances are compliant in that the controls are located at the front and have clear accessible approaches.

View of the community room kitchen

- Budget to replace the cabinets in year 1.
- Budget in year 1 to replace the countertop in conjunction with cabinet replacement.

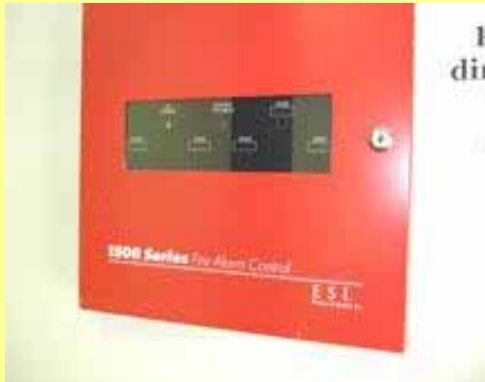
There is a central intercom panel in the vestibule at the front of the building. The highest button is located at 65-inches and the office call button is at 45-inches. There is a central fire alarm control panel by ESL (1500 Series) with the common area devices being hardwired. The panel was replaced in 2004. Discuss installing a fire department notifier at client review.

View of the fire alarm panel

- Budget in year 10 to replace the intercom panel.
- Budget in year 15 to replace the fire alarm panel.

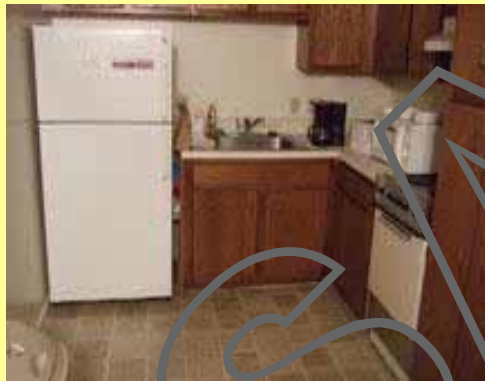
The accessible kitchens have a 60-inch turning radius, however there are no knee spaces. The countertops are laminated particleboard with a rounded edge and backsplash. The single bowl sinks are stainless steel and have a single handled faucet by Moen. Gate valves are under the sink. The accessible countertop is set at 36-inches high and has a shallow bowl sink and lever faucet. The kitchen appliances are compliant in that the controls are located at the front and have clear accessible approaches. Accessible refrigerators have the controls at the front and have over 50% of the shelving area within accessible reach ranges.

Typical accessible kitchen

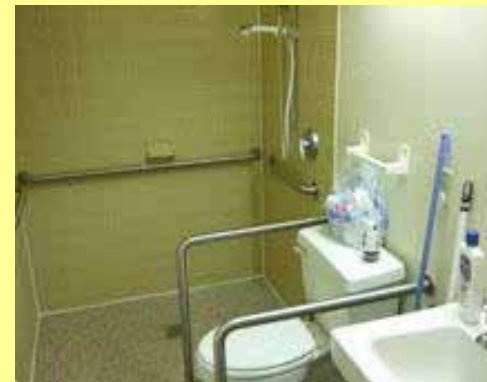
Bathrooms do not have a 60-inch clear turning radius. Bathroom accessories include a semi-recessed mirrored medicine cabinet (38-inches), soap dish, toothbrush holder, toilet paper holder, and a towel bar. The accessible units have floor/wall mounted grab bars both sides of the toilet. The toilets have a seat height of 18-inches from the floor. The grab bars restrict the clear approach to the toilet. The accessible units have a wall-mounted lavatory with a Moen single handled faucet with aerator. Pipe wrap was observed under the lavatory. The accessible units have a roll-in shower stall with grab bars (1.5-inches in diameter, 1.5-inches away from the wall, and 33-inches high). There is no shower seat provided.

Typical accessible bathroom
